GALLATIN GATEWAY SCHOOL DISTRICT PREBOND

Gallatin Gateway, MT

June 12, 2020

Assessment Report Draft

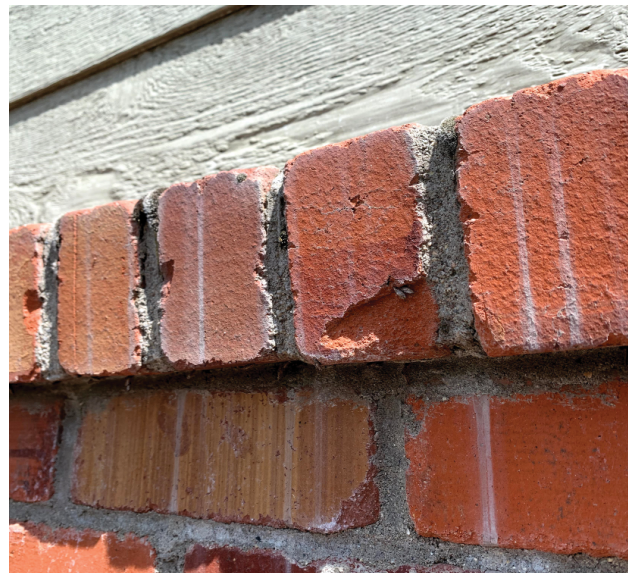
Wear of skyward joints along west wall.

- Top course of masonry at wainscot – generally good condition, with failure at one elevation. The West elevation top course of brick is showing wear at all skyward joints and bricks are spalling. Recommend re-pointing of all joints, replacing bricks that are beyond repair, and additional flashing to cover the skyward surfaces on this elevation.

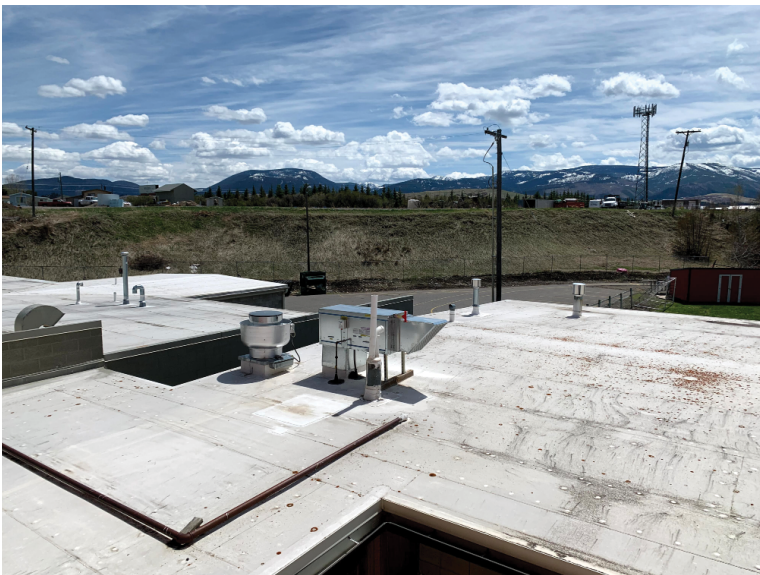
- The asphalt shingles appear to be in good standing condition.
- The membrane roofing shows wear at seams along with some organic growth scattered across entire surface, and portions of sealant are receding at termination bar on vertical surfaces. This product is nearing its typical lifespan.

Roofing material over building additions.

- Recommend to verify the installation date of the original membrane product to confirm lifespan, and replace sealants as needed until new roof installed. When new roofing is applied, verify if existing roofing layers reside below with core samples, (potential for hazardous materials from original construction).

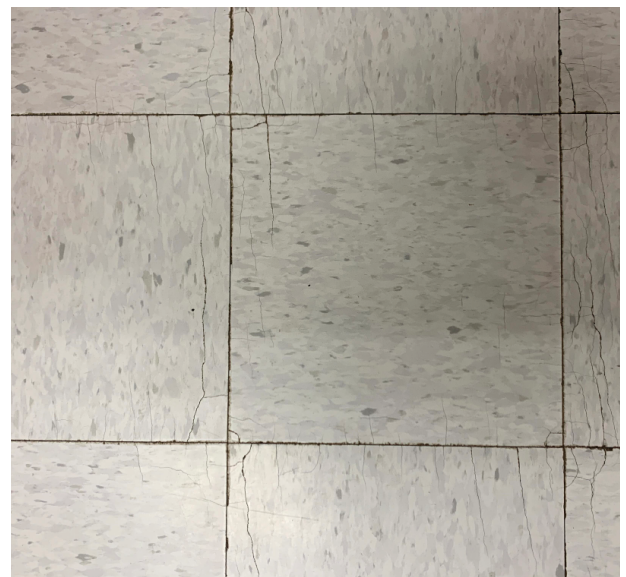
- VCT tile floors – majority of VCT tiles are failing & subfloor is warped within the 2001 addition. This occurs throughout the main entry lobby, corridor to the west, and one classroom. Recommend to remove all and replace with new flooring and subflooring as required during removal process.

Failing VCT tiles.

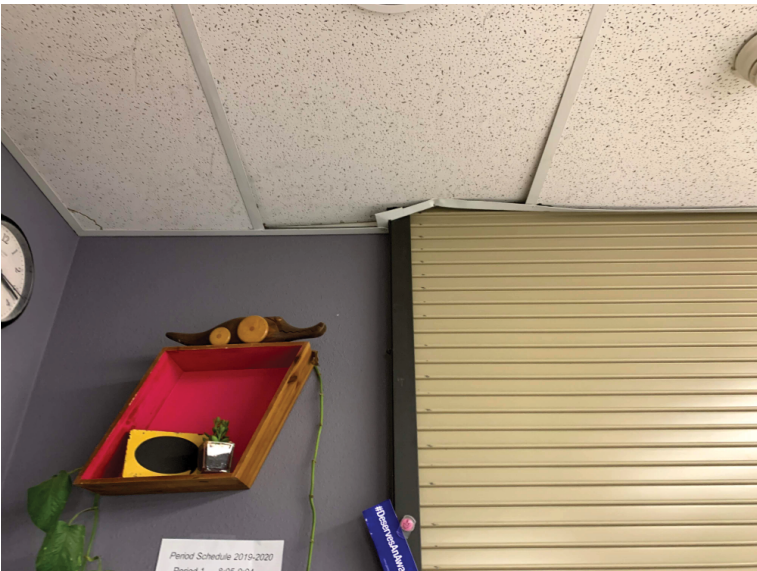
Concentrated damage at ACT ceiling.

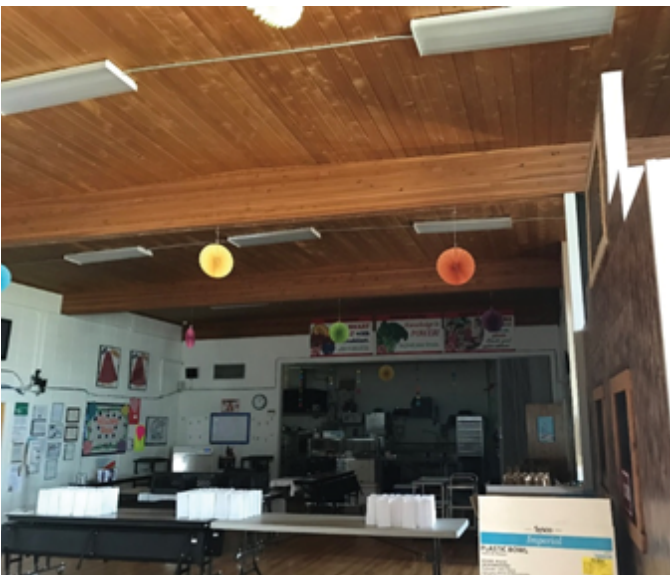
The cafeteria consists of large tapered glued-laminated (glulam) beams that were measured as at least 21 inches deep from the bottom to the roof framing. These beams span from the north to south walls at 12 ft on center and support horizontal planking, seen in Figure 2. All four perimeter walls are CMU placed in stack-bond with a concrete slab-on-grade floor. All observed structural elements appeared to be in good condition.

Figure 2 - roof framing in Cafeteria.

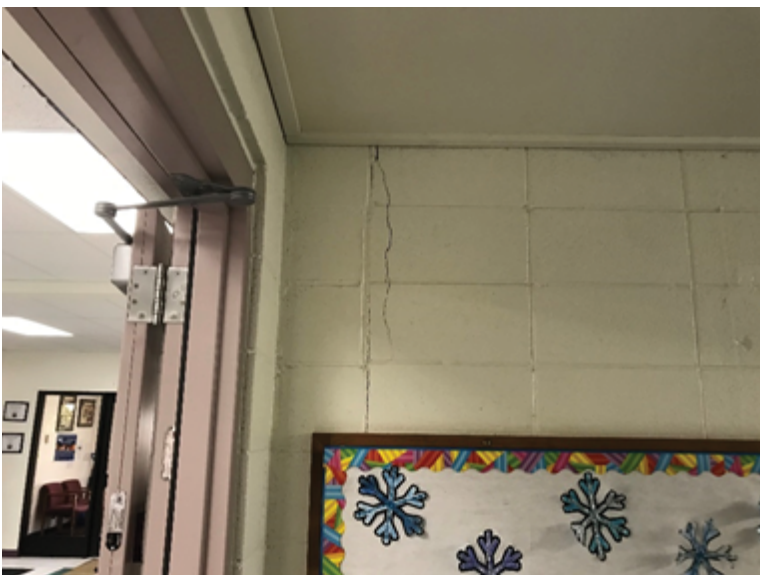
Visible elements of the roof structure appeared to be in good condition and there were no signs of overstress. The CMU walls also appeared to be in good condition overall. The only notes damage of structural concern is a larger crack at the interface between the 1966 addition and the 2003 addition. This crack was most likely caused by the rigid connection between the older and newer CMU walls. The foundation wall was retaining soil prior to the 2003 addition, and there may have been foundation movement during the excavation process paired with the rigid connection is likely the cause of this cracking. Figure 4 shows the cracking that is occurring at the top of the wall along one of the vertical joints between the CMU blocks as well as one that extends through at least three blocks.

Figure 4 - CMU wall cracking at addition interface.

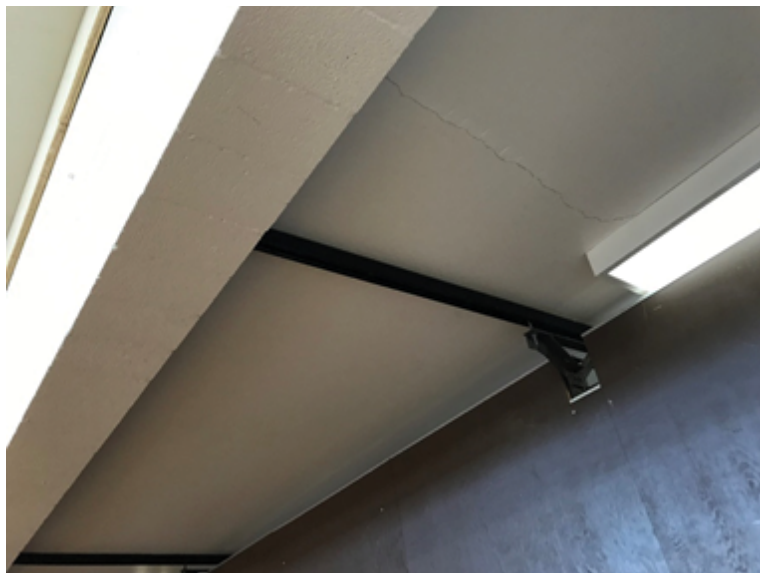
Figure 5 - cracking at Moveable Bleacher Track

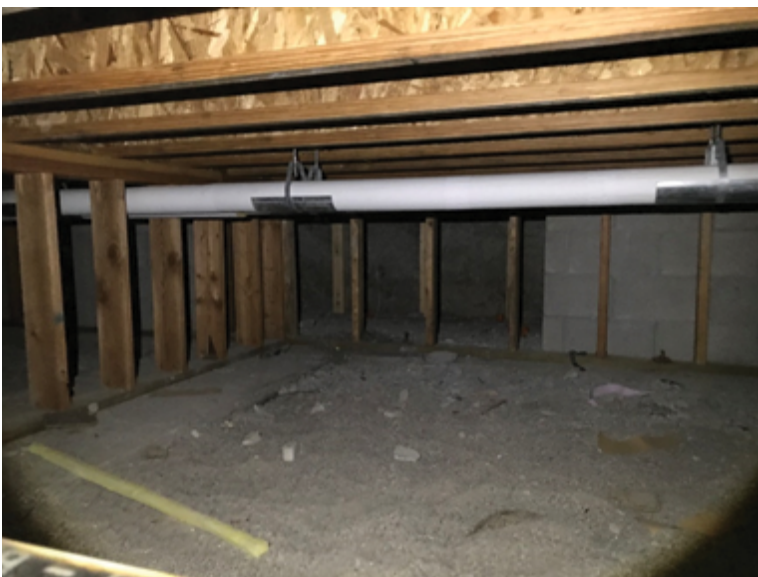
Figure 6 - crawlspace framing.

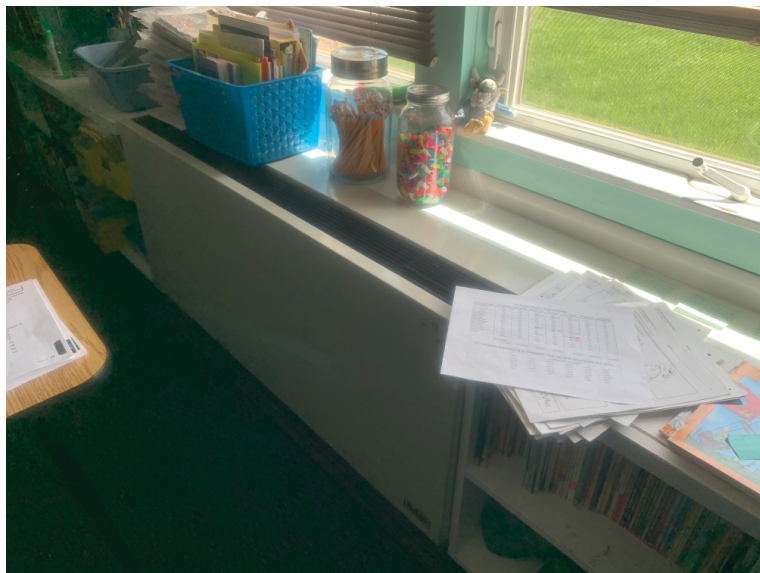
Existing Unit Ventilator in Classroom.

- Improved ventilation to all classroom spaces.
- Economizer cooling for free cooling when outdoor conditions are appropriate and mechanical cooling when required, to improve occupant satisfaction.
- Newer technology incorporates variable speed fans, quieter operation, and lower heating water temperatures.
- Intended to be a low impact HVAC replacement option.

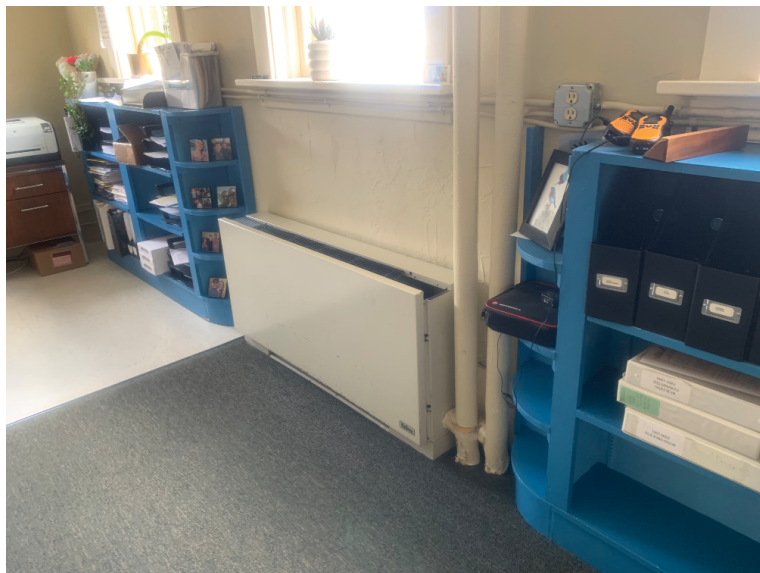
Existing Unit Ventilator.

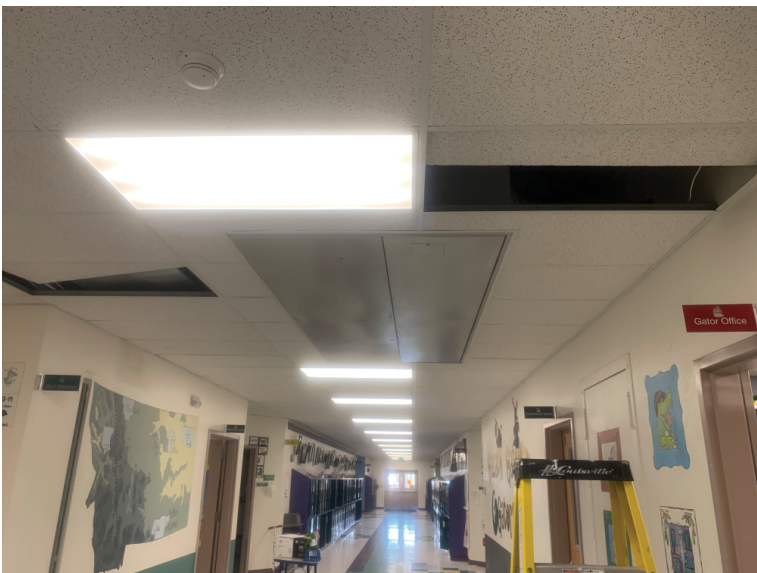
Existing Cabinet Unit Ventilator Serving Admin Area.

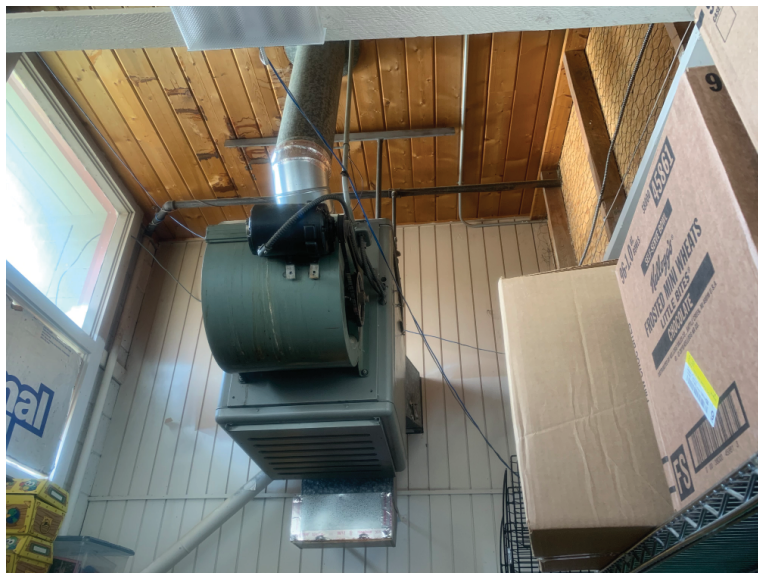
Existing Cafeteria Air Handling Unit.

- Replace end-of-life equipment with new equipment.
- Equipped with DDC for monitoring and administrator control.
- Demand control ventilation reduces energy cost by only providing the appropriate amount of ventilation based upon space utilization.
- Economizer cooling for free-cooling when outdoor conditions are appropriate.

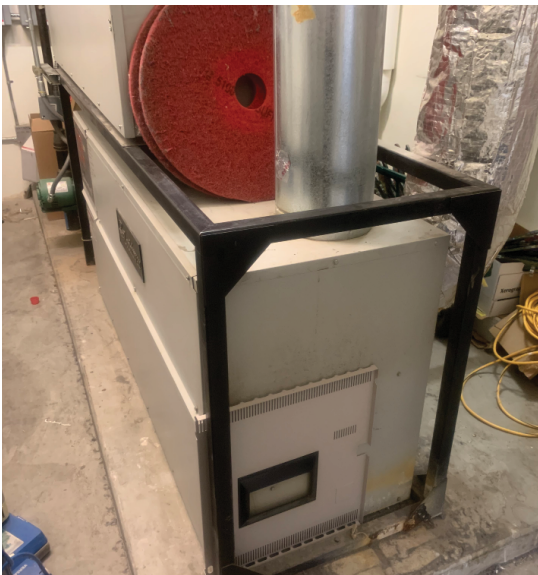
Existing Lochinvar Boilers in 2001 Addition Boiler Room.

- Replace end-of-life equipment with new equipment.
- High efficiency, condensing boilers reduce energy cost.
- Equipped with DDC for monitoring and administrator control.
- Consolidated boiler plants into a single boiler room.

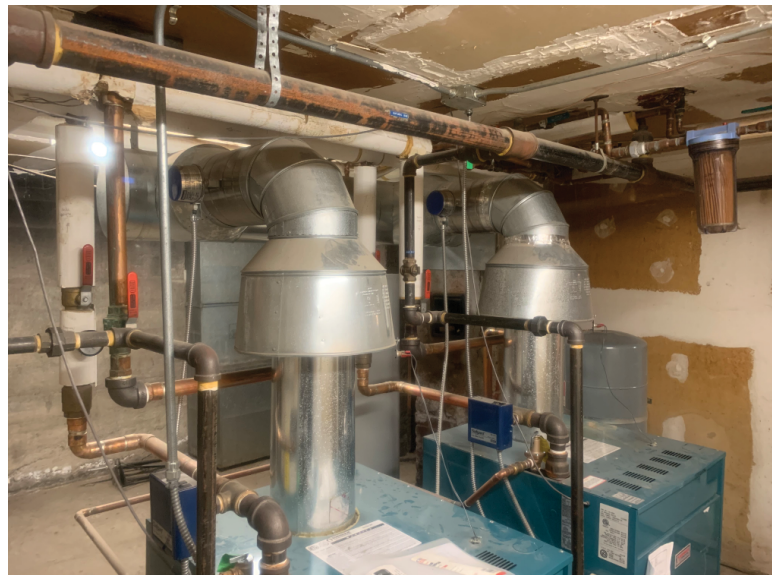
Existing Burnham Boilers in Basement Boiler Room.

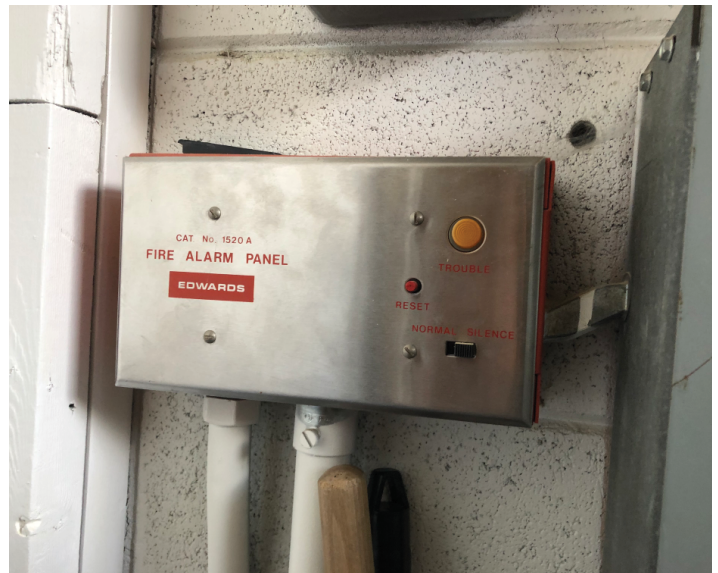
1960's Edwards FACP.

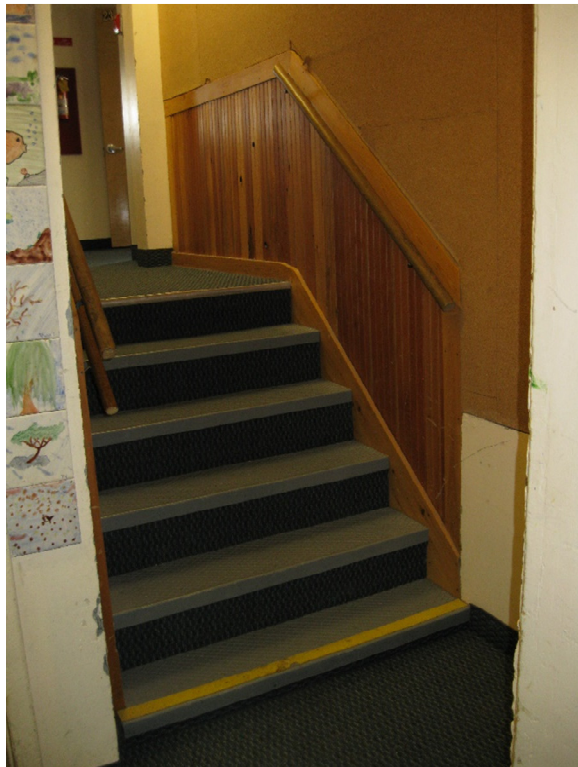
Stair – Mid-landing to First Floor

The bottom riser between the mid-landing and the first floor is considerably shorter than the remaining risers.

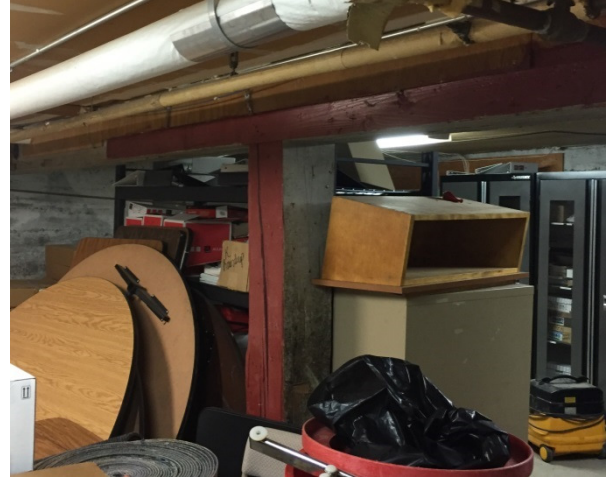
The first floor framing was observed from the unfinished basement space below. The first floor joists are 2x12 nominal and span from the exterior north and south bearing walls to an intermediate beam that consists of 6-2x12 members. Splices at this beam are random, and therefore the beam was considered 4-2x12 for analysis purposes. This beam spans continuously over column elements spaced at approximately 12 feet on-center. These columns are approximately 9-inches square and bear on the cast-in-place concrete basement slab below. At the east and west walls, the beam pockets into the concrete basement walls.

Figure 3: Typical beam to column connection in the basement.

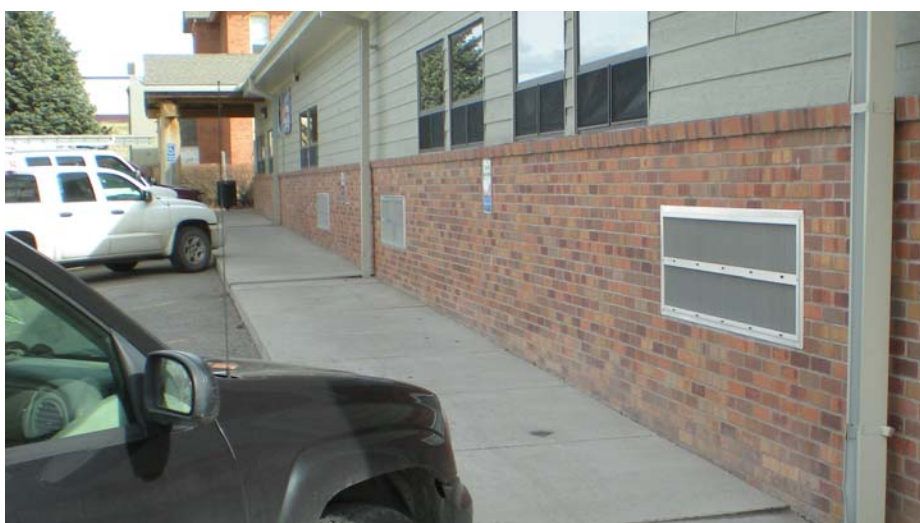
North Classroom Air Intakes

Currently, the entire building is negatively air pressured causing cold drafts during winter months that create an uncomfortable building. This air pressurization issue is being caused by a lack of outdoor ventilation air being brought into the building. The problem is increased when the kitchen exhaust hood is utilized. The 2001 addition brought ventilation air via unit ventilators into the building however, it is not enough to offset the rest of the building. In fact, the three unit ventilators on the North Side of the 2001 addition have outdoor air intakes that are five feet from the parking lot. These units have drawn car exhaust fumes into the classroom from the parking lot. Besides the classrooms installed during the 2001 addition, there are not any other classroom that have mechanical ventilation.

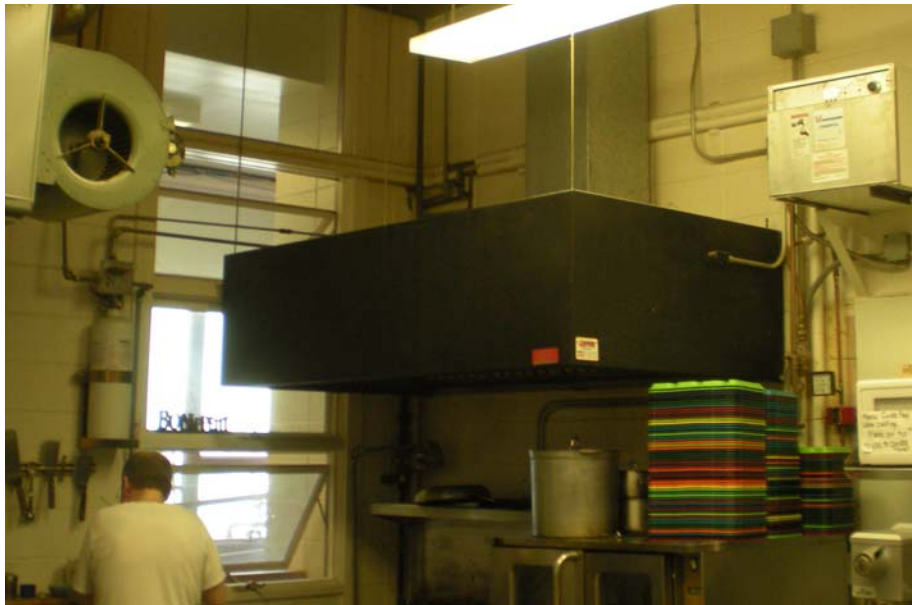
Kitchen Exhaust Hood

The lack of proper make-up air for the Kitchen exhaust hood is a code violation and should be addressed. CTA recommends that a new gas-fired make-up air unit is installed to provide proper make-up air for the Kitchen. The new make-up air unit would be located on the roof near the kitchen and be interlocked with the kitchen hood exhaust fan. This will address the air deficiency associated with the kitchen hood system. As part of this facility measure to upgrade the building's ventilation system, we recommend blocking the outside air intakes on the three north unit ventilators near the parking lot. In order to replace the ventilation air lost by doing this we recommend installing a heat recovery ventilator on the roof near the two toilet rooms. This ventilator would recover heat from the existing toilet exhaust and bring ventilation air directly to the classroom. This is otherwise known as a dedicated outdoor air system. Outside air would then be brought in from the roof level and not at parking lot level. The last part of this ventilation upgrade would include adding mechanical ventilation to the four classrooms between the library and the cafeteria along with adding ventilation to the two classrooms near the locker rooms. Ventilation would be accomplished via small rooftop heat recovery ventilators. Exhaust heat would be recovered and put back into the new ventilation air stream. This measure will have a positive impact on the indoor air quality and slightly increase energy usage. Refer to Appendix D for further detail on implementation costs and Appendix C for energy reduction calculations.

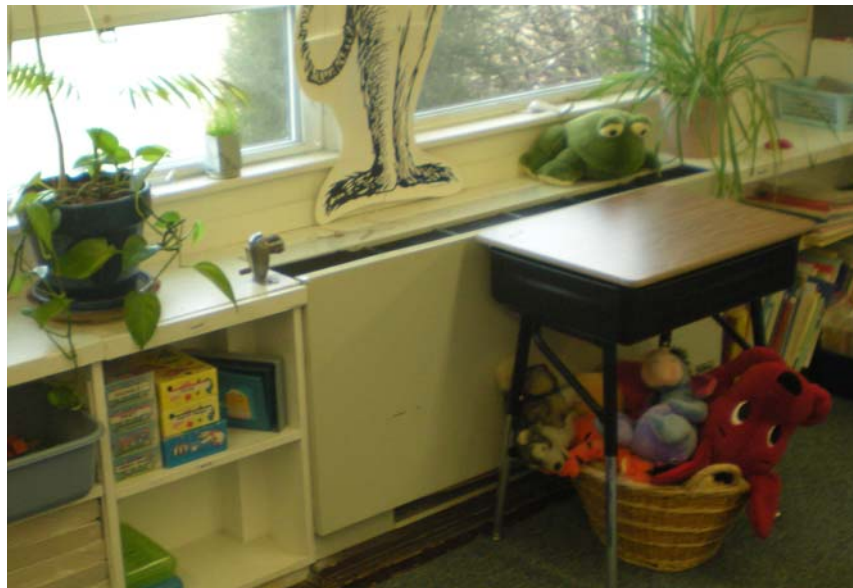
Class Room Fan Coil

The 2001 addition to the building incorporated a limited digital temperature control system for the new areas. The rest of the building remains with either pneumatic or electric controls. The areas served by the original temperature control system are very uncomfortable as these systems have essentially failed and manual control is prevalent. There are no means of night set back or other energy reduction features. The administration area is another area that is in need of temperature improvement. Several interior spaces such as the conference room have been put on the same temperature control zone as the exterior office spaces. This makes the conference room and adjacent interior spaces very hot in the winter months when the exterior spaces require heating. The library and the interior restrooms have a very similar issue. Because of deficient temperature controls the heating coil in the unit ventilator that serves the computer lab has frozen. The computers provide the only heat source in the room and it has been very uncomfortable during colder outdoor ambient conditions.

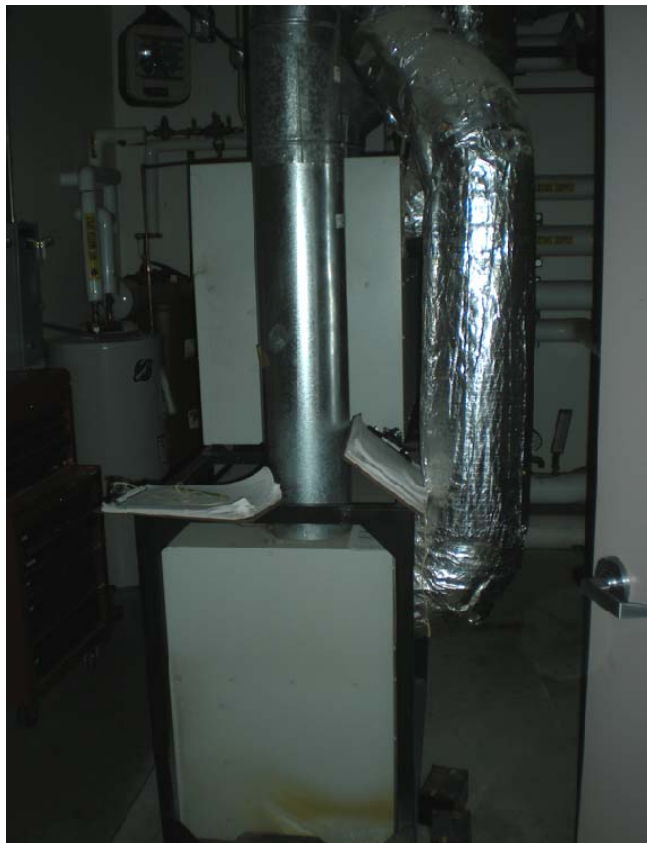
Lochinvar Copper Finned Boiler Installed 2001

Even though the two boiler plants in the building are fairly new they are not very energy efficient and already have a history of high maintenance. We normally wouldn't recommend a boiler replacement for equipment that is 10 years old but given the history of high maintenance and this building's ability to take advantage of low-temperature high efficiency boilers we recommend that the existing Lochinvar Boilers be replaced with new high efficiency condensing type boilers to serve the entire school. Under this improvement two new 800 MBH condensing type boiler would be installed. Main distribution piping would be extended to the basement mechanical room to turn the Burnham boilers into a back-up boiler plant. This measure would consolidate the boiler plants such that the entire facility was served by the new condensing boilers.

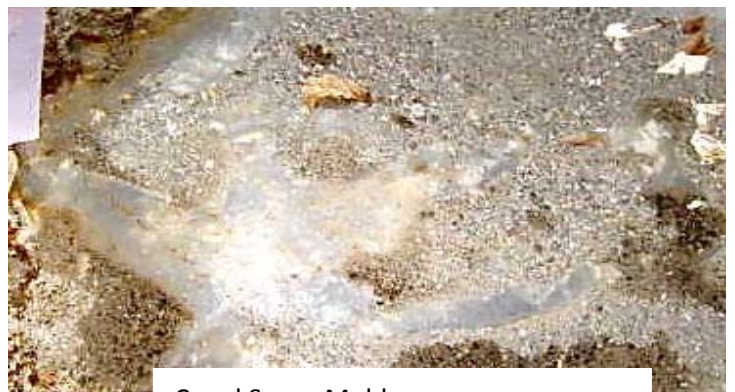
Crawl Space Mold

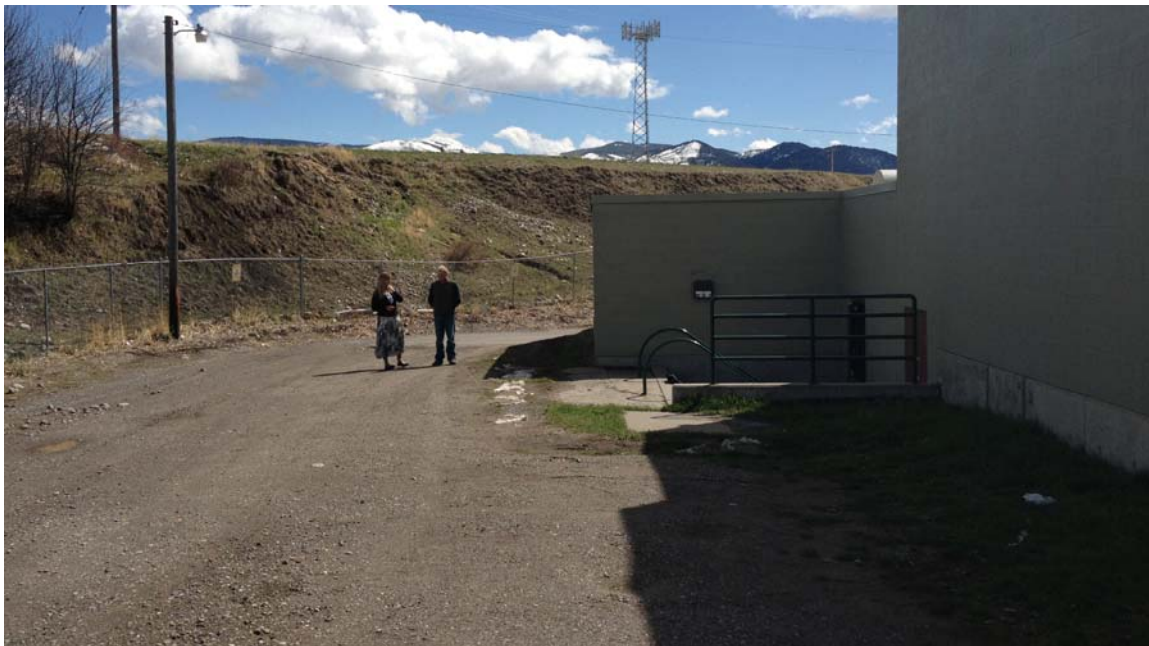
Interior flooding has been problematic at the eastern, below grade access, adjacent to the gymnasium. A concrete stairwell descends approximately 5 vertical ft to the landing. A concrete pad has been poured at the top of the stairs, but appears to be settling, and sloped towards the stairwell. On-site investigation determined that a large portion of the storm drainage from the access road was ultimately being directed towards the stairwell. An exterior floor drain has been installed, but due to the large volume of sediment likely being transported with each storm event, has either failed or become clogged. At a minimum, it is recommended that the floor drain be inspected and cleaned out to the most realist extend possible. South of the stairwell, and behind the building, the parking area has been paved with a storm drainage catch basin being observed.

Recommendation: Three remediation options, along with the associated costs and benefits, have been explored and presented here within.
