# June Special Meeting Agenda

Review & Discuss Industrial Hygiene Report- Northern Industrial Hygiene, Inc.

**Photograph Log  
Limited Mold Assessment  
Gallatin Gateway School  
100 Mill Street  
Gallatin Gateway, Montana  
Project: 399-997**

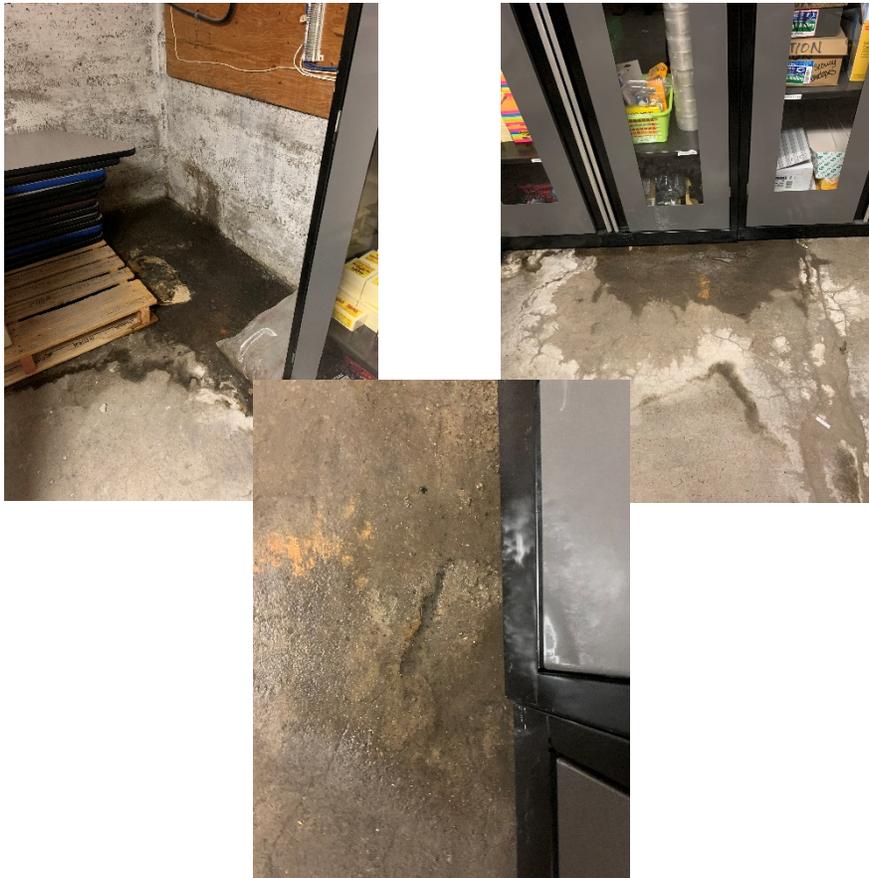
1. An area of wet concrete, including puddles, was visible in the corner of the basement.

1. Repair and eliminate all areas of water intrusion - mold cannot grow without moisture.
2. Cistern tanks to catch rainwater from the roof may help minimize the ground water available to seep into the school. As the school sits in a bowl, all water from run off, roofs, streets, etc. collects in the bowl and can penetrate the school foundation. The collected water could be used to water the lawn throughout the summer.

3. French drains installed below the level of the foundation to move water out of the bowl may also help limit available ground water.
4. Remove water damaged porous building materials and treat all water damaged non-porous building materials with a surface and substrate cleaner to remove organic contamination. HEPA vacuum and damp wipe all treated surfaces to remove fungal/mold spores.

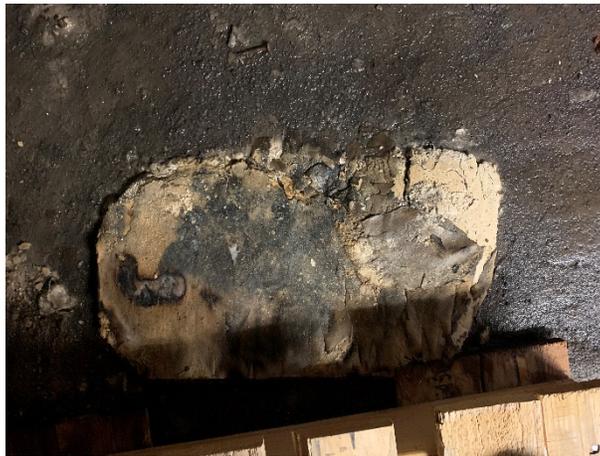
2. Debris found within the puddle shows visible mold and fungal growth. The wood pallets being used to keep the stored contents out of the water are starting to support mold growth.

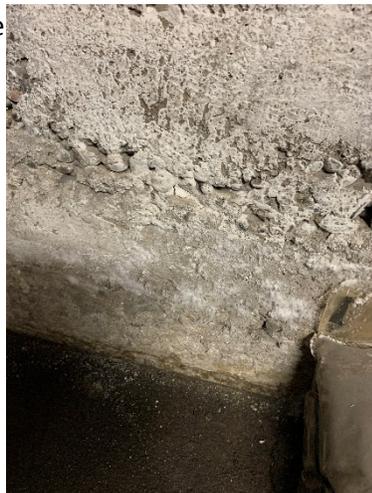
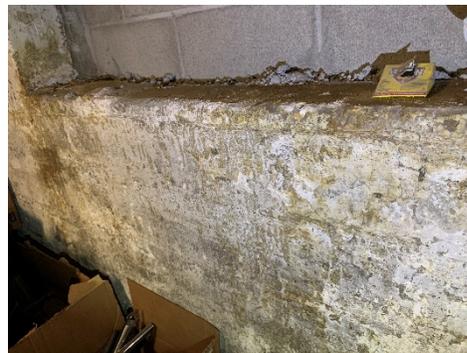
3. Extensive mineral efflorescence was found throughout the entire basement – the efflorescence clearly shows as a water line in the boiler room. The extent of the efflorescence indicates multiple water intrusion events.

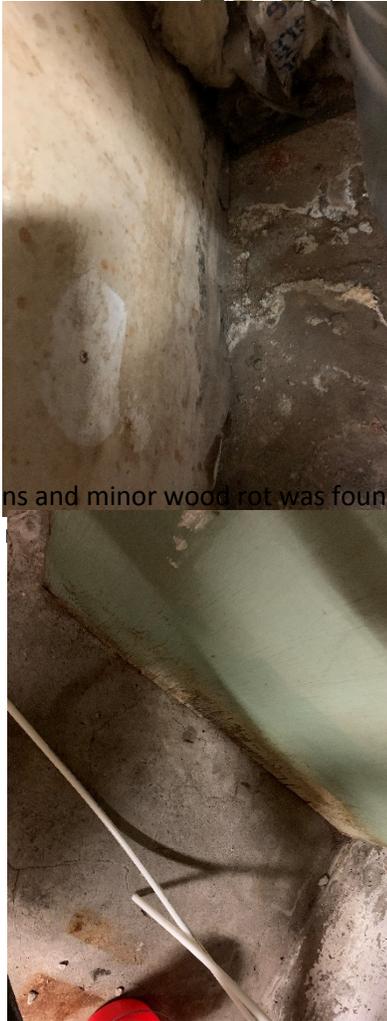
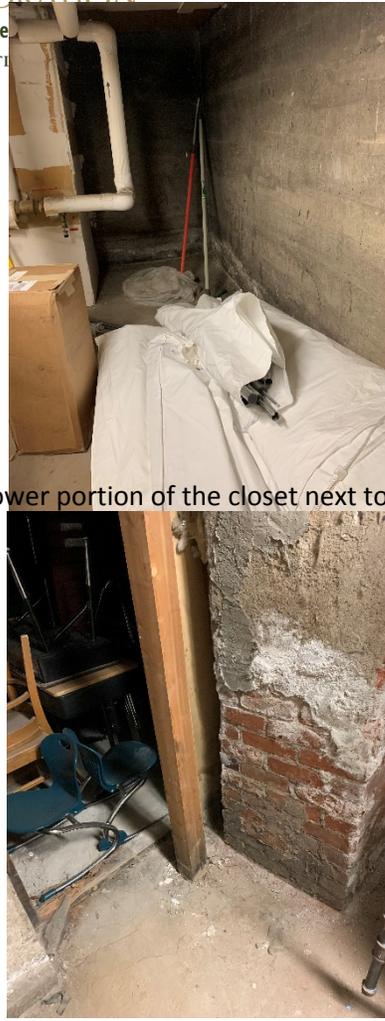
- 4. Water stains and minor wood rot was found on the lower portion of the closet next to the stairs and on a sill plate

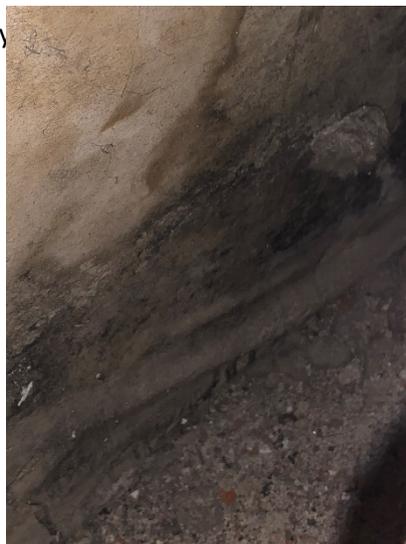
- 5. Visible growth found on the dry [redacted] boiler room.

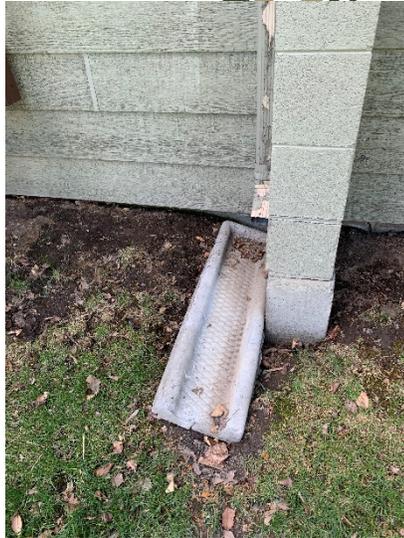
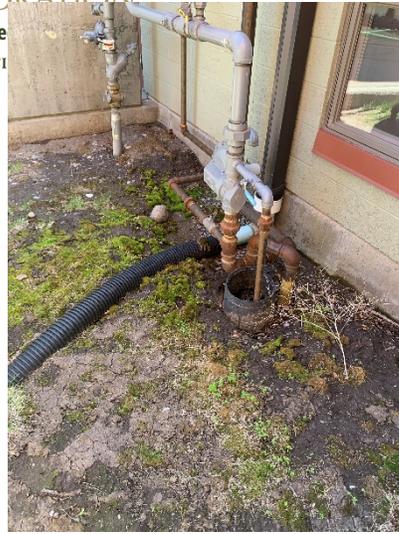
- 6. Areas of moss and fungal growth found near the downspouts on the exterior. This indicates the area is not drying quickly and potentially indicating elevated ground water levels.

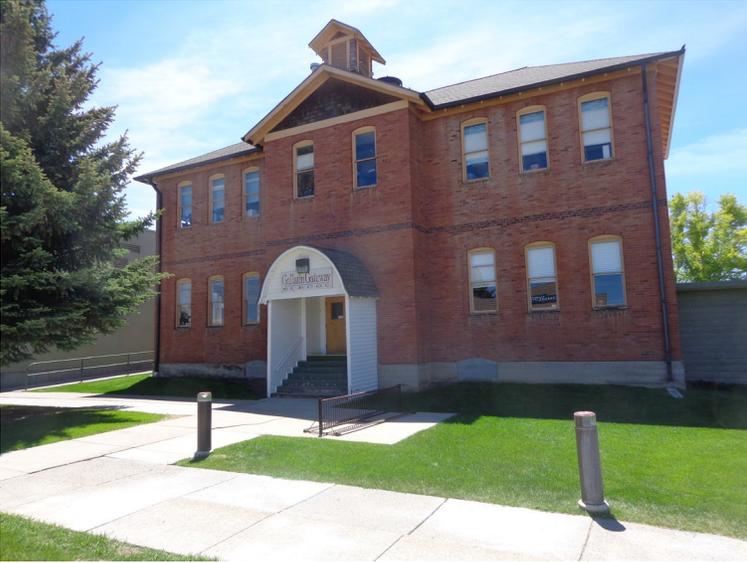
The exterior finishes of the 1914 section include a concrete masonry foundation, brick exterior and an asphalt shingle roof. (Photograph #1).

Photograph 1: View of school's original 1914 build exterior.

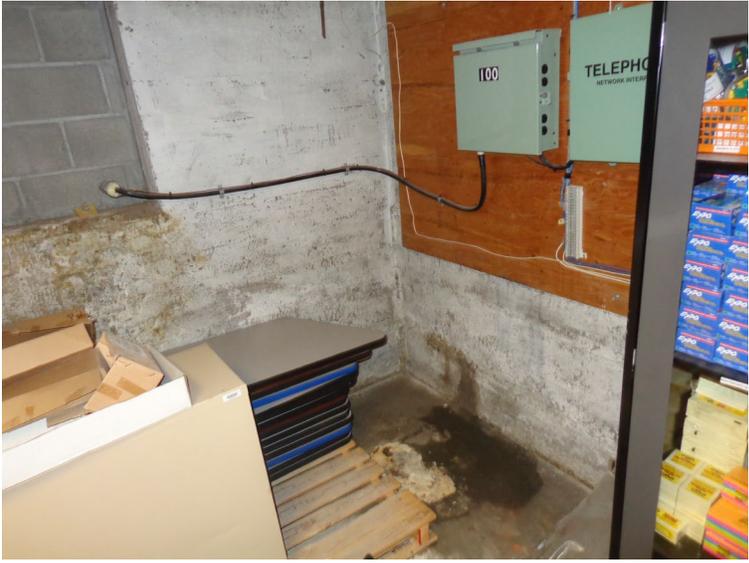
Upon entering the basement Northern noted a musty/moldy odor. Northern observed water staining on the lower wall and floor in the northwest corner of the basement. A water-stained wood pallet and a piece of deteriorating cardboard were observed in this area. No elevated moisture levels were found in this area. One air sample was collected in this area. (Photographs 2 and 3)

Photograph 2: View of the basement's northwest corner showing water staining on northern wall and floor.

- Remove all organic materials from the basement and dispose of or store in another location.
- Consult a building engineer to investigate the water intrusions in the lower north wall of the basement and determine the structural integrity of the chimney.
- Remove one foot of the lower gypsum board wall on the south side of the boiler area. Replace with a non-organic material.
- Determine the significance of the hole in the floor of the boiler area and, at a minimum, place a drain cover over the opening.
- Consult a remediation company to clean the basement and use HEPA filtration air scrubbers during remediation.

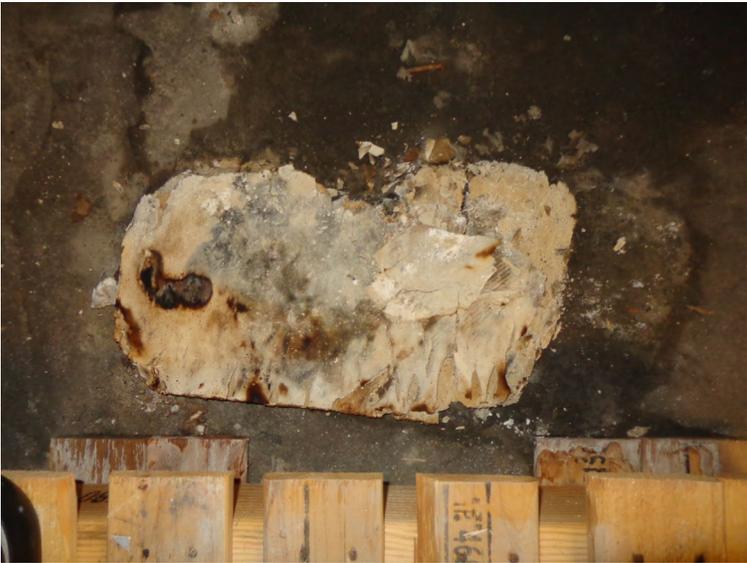
Photograph 3: View of deteriorating cardboard and water-stained wooden pallet on floor in northwest corner of the basement.

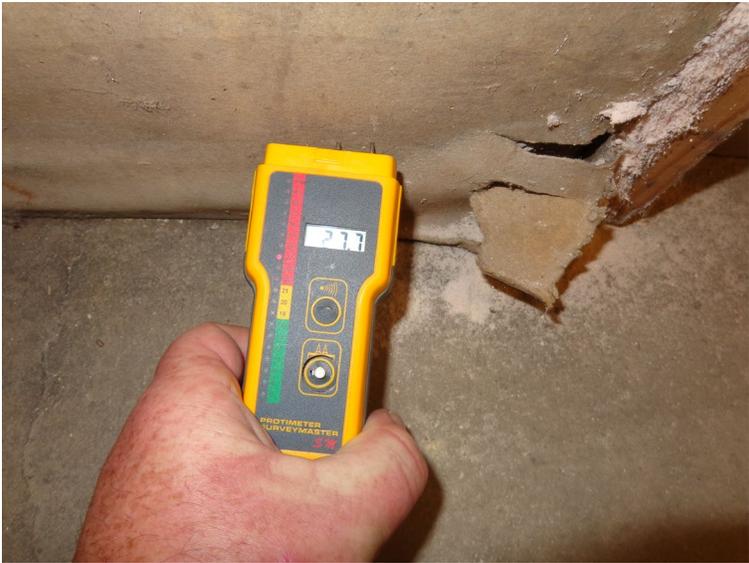
The boiler portion is located in the center of the basement along the northern wall. It is sectioned off by gypsum board walls. The lower gypsum board wall on the south side contains elevated moisture levels. (Photograph 4)

Photograph 4: View of elevated moisture reading (27.7%) in the deteriorating gypsum board on the south wall of the boiler area.

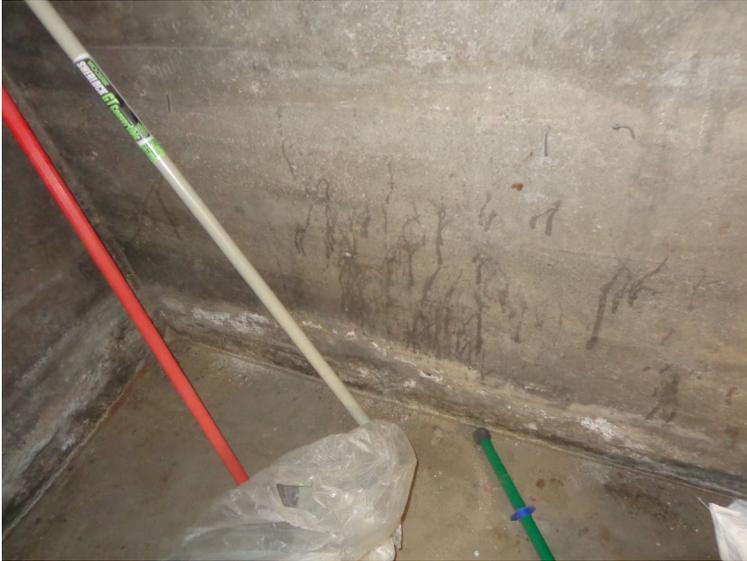
Water staining was observed along the northern concrete wall approximately one foot above the floor. A hole was noted in the floor where the boiler pressure release pipe is located. Another PVC pipe enters the boiler area through the ceiling and enters this hole. (Photographs 5 and 6)

Photograph 5: View of water staining on the lower north concrete wall in the boiler area.

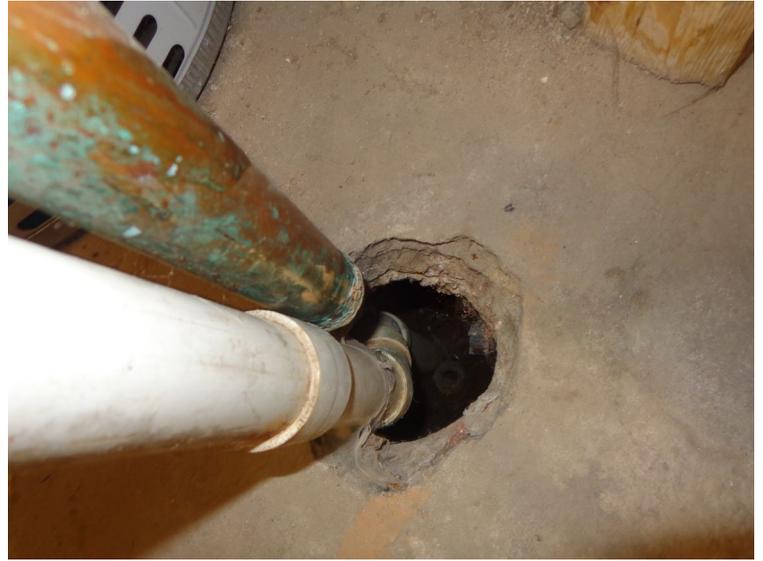
Photograph 6: View of a hole in the concrete flooring in the boiler area.

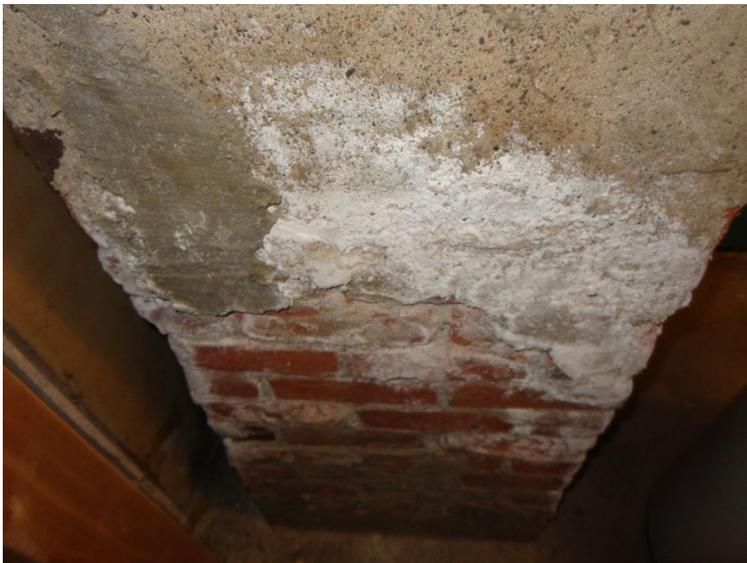
A brick chimney located in the boiler area which is used as the boiler exhaust contained areas of efflorescence "crystal-like fibers" forming on the outside of the bricks. Some areas of the brick chimney were soft and deteriorated with little hand pressure. One air sample was collected in this area. (Photograph 7)

Photograph 7: View of the deteriorating chimney in the boiler area with efflorescence present, an indicator of elevated moisture content.
