GALLATIN GATEWAY SCHOOL DISTRICT PREBOND

Gallatin Gateway, MT

June 12, 2020

Assessment Report Draft

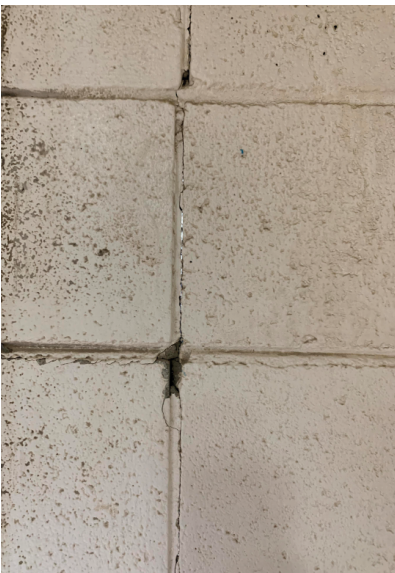
Joint Failure at CMU walls.

- CMU walls – generally in serviceable condition with some areas of failure.
 - Portions on the south elevations show joint failure and recommend replacement of backerrod and sealant.

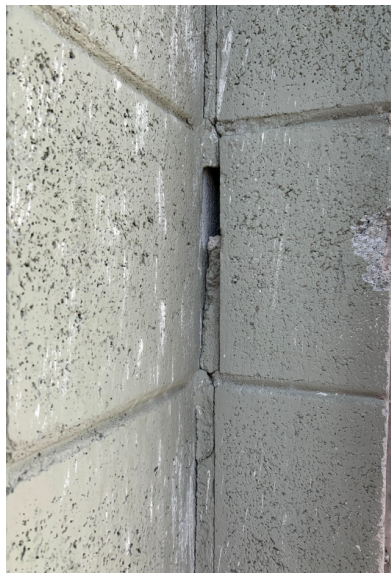
Wear of skyward joints along west wall.

- Top course of masonry at wainscot – generally good condition, with failure at one elevation. The West elevation top course of brick is showing wear at all skyward joints and bricks are spalling. Recommend re-pointing of all joints, replacing bricks that are beyond repair, and additional flashing to cover the skyward surfaces on this elevation.

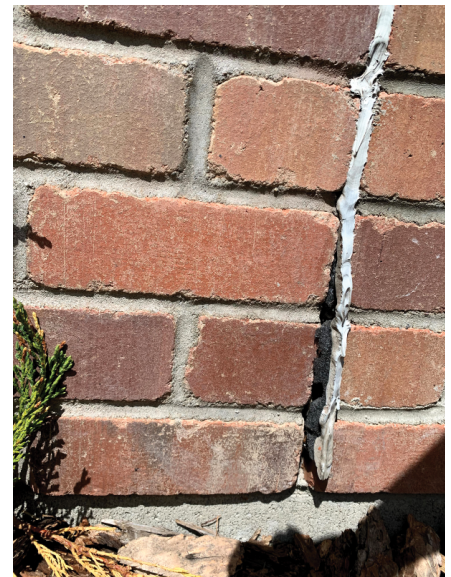
- The North and South elevations have masonry joints failing at wainscot – remove as required and reapply backerrod with new sealant for full distance of joint.

Joint Failure at masonry walls.

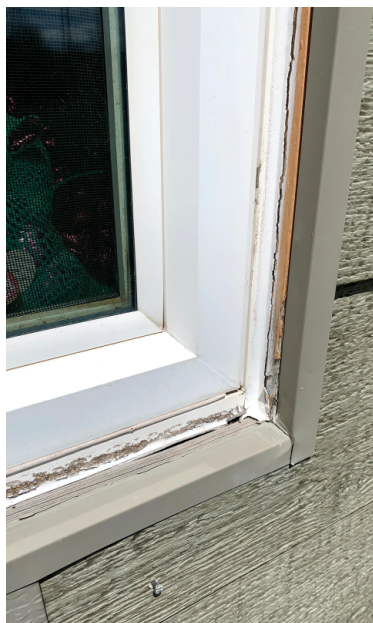
- 1966 portion classroom windows – appear to have additional layer of siding and trim around windows without still flashing. The trim around the windows does not allow for consistent directional flow down/out from siding. Concern with water/moisture being trapped between old and new materials causing failure at perimeter of windows. If interior leaking is present, recommend further investigation of these windows. Otherwise fill voids present with backerrod and sealant.

Additional layer of siding at windows.

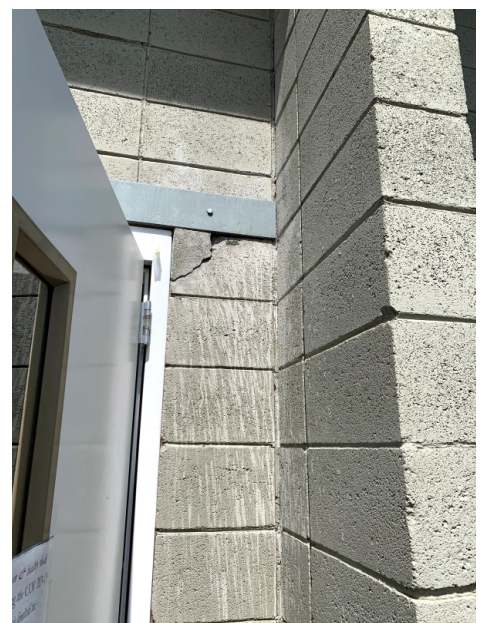
- Hollow metal doors – generally all exterior doors are hollow metal type and in good condition with minor wear.
 - The door opening at the kitchen/cafeteria is not fully concealed – gaps present at head and jamb. Provide backerrod and sealant. Confirm steel lintel support is adequate for opening with CMU joints exposed.

Gaps around door opening.

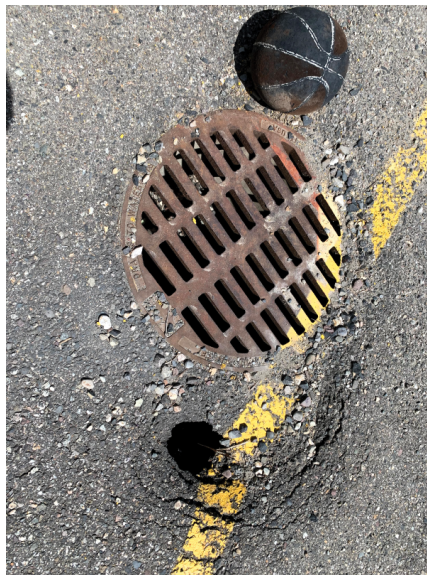
- Other areas of the site are showing additional wear.
 - The southwest corner of the building – manhole area – asphalt is failing and an 8" diameter hole is visible adjacent the manhole. This could present a hazard being adjacent the playground area.

Worn asphalt around drain.

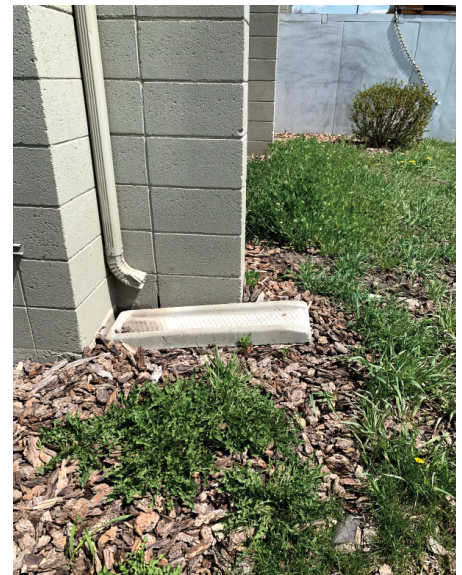
- Downspout concrete bases – typically along the south elevation need addressed – they slope back pushing all downspout water toward the building. Re-grade below each of these to provide positive drainage (away from building).

Concrete base directing water back towards building.

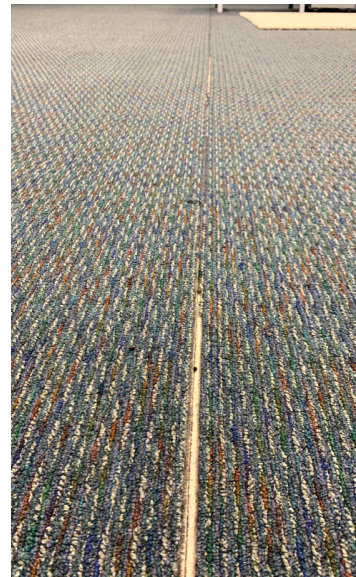
- Carpet - generally in serviceable condition overall.
 - Offices, admin area, and Library show some wear marks and minimal areas of stains on carpet.
 - Classrooms in the 2001 portion have failing seam lines/gaps with carpet rolls. Recommend filling or fully replacing if this is a hazard or limits chair and desk movement needs for student seating.

Failing seam lines in carpet.

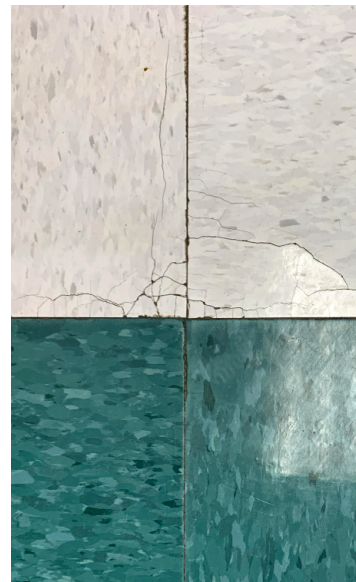
- VCT tile in 1960's and 1978 portions appears to be in serviceable condition. Recommend reviewing the existing hazardous materials report the school district has prior to any construction modifications to the flooring in these areas.

Failing VCT tiles.

- Consider replacement in the near future of the mechanically fastened white membrane roofing areas.
- The additional interior building recommendations are to remove and replace the failing VCT flooring in the 2001 portion with a product suitable for the subfloor/structure and traffic associated with this area.

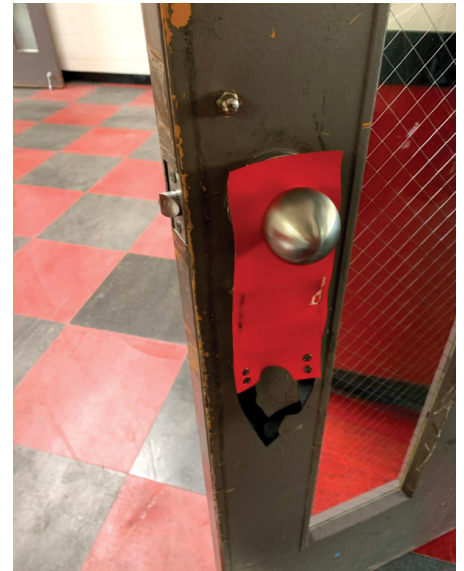
Revisit door hardware.

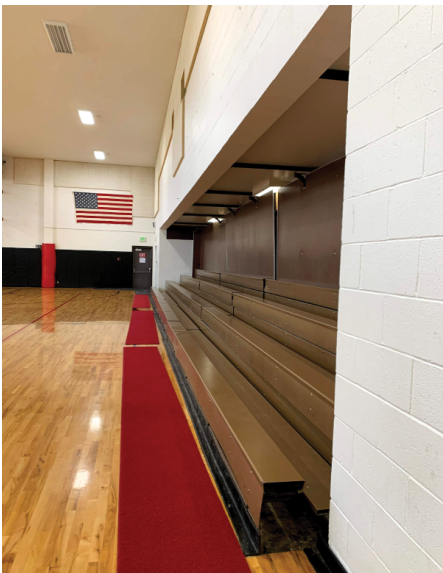
- Gymnasium bleachers – current bleachers are no longer functioning/retractable and do not provide adequate space between court lines and spectators. Additional exiting deficiencies related to this area need further review – see 2016 assessment report.

Gymnasium bleachers.

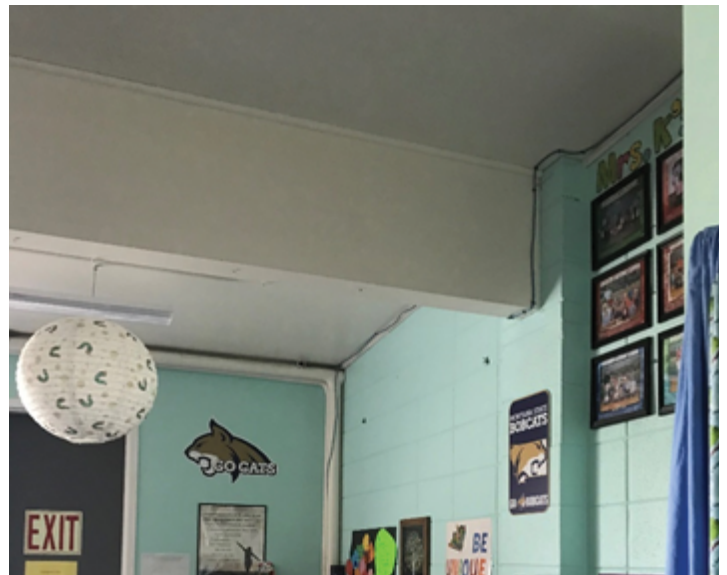
Figure 3 - roof beam at CMU Pilaster in Classroom.

Visible elements of the roof structure appeared to be in good condition and there were no signs of overstress. The CMU walls also appeared to be in good condition overall. The only notes damage of structural concern is a larger crack at the interface between the 1966 addition and the 2003 addition. This crack was most likely caused by the rigid connection between the older and newer CMU walls. The foundation wall was retaining soil prior to the 2003 addition, and there may have been foundation movement during the excavation process paired with the rigid connection is likely the cause of this cracking. Figure 4 shows the cracking that is occurring at the top of the wall along one of the vertical joints between the CMU blocks as well as one that extends through at least three blocks.

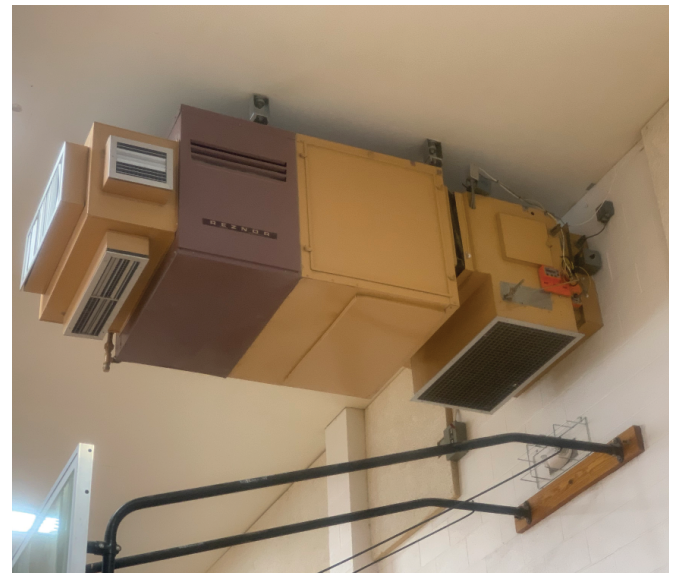
Existing Gymnasium Air Handling Unit.

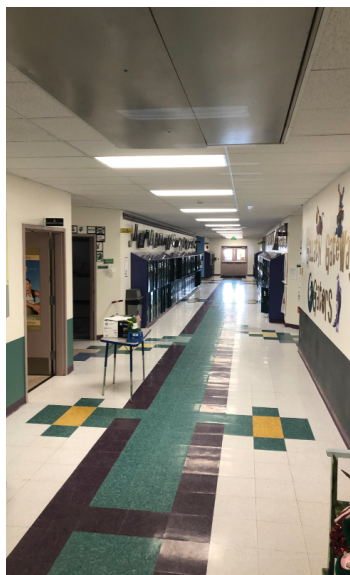
1. General Lighting: The 1914 era portion of the school does not contain adequate lighting in terms of light levels or uniformity, and the lighting controls are no longer serviceable. If this portion of the school is to be used for anything more than occasional storage, a complete relighting of the building would be necessary. Surface mounted LED lighting and wireless lighting controls are two options for relighting these spaces, which minimize damage to historic finishes and reduce installed cost.

2001 Hallway Fluorescent Lighting.

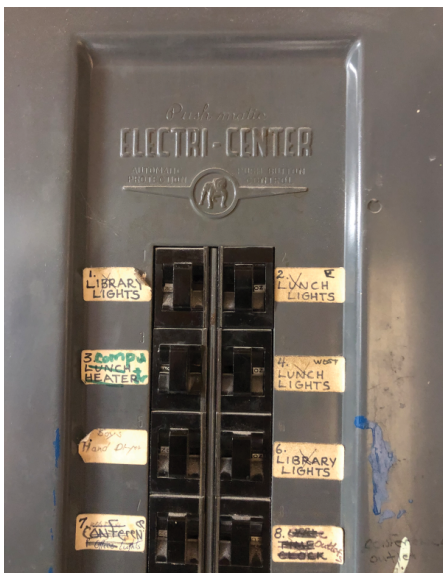
The electrical service equipment itself is relatively new (2001 era) and in fair condition, but much of the downstream electrical infrastructure throughout the school, particularly in the 1914 original schoolhouse, is well past its serviceable life. Panelboards and wiring in portions of the school built between 1914 and the mid-1960s are also of concern for safety reasons. Staff mentioned seeing visible arcing when operating breakers in some of the older "pushmatic" panels located within the 1914 schoolhouse.

1914 Era "Pushmatic" Panelboard.

2. Panelboard Replacement: Older panelboards with "pushmatic" style breakers should be replaced with modern panelboards with bolt-on, thermal magnetic breakers. These older panels are no longer serviceable and they pose a safety risk to those who operate them.

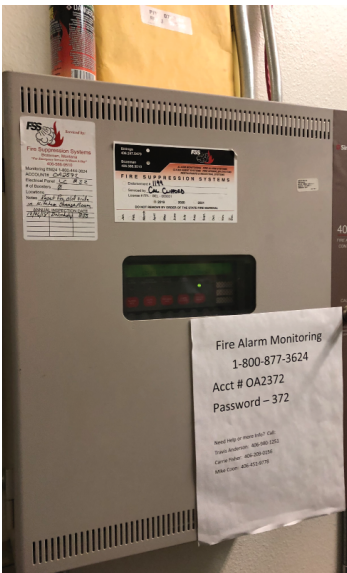
Based on conversations with staff, it seems there are two separate fire alarm systems. One is the older Edwards system and the other is the Simplex/Hybrid system. This duplication of fire alarm systems is not desirable and should be remedied as soon as possible.

2001 Simplex and Fire Watch FACP.

1. Replace outdated/complex Fire Alarm System: From a life safety perspective, replacing and consolidating the school's fire alarm system under a single manufacturer and warranty should be the highest priority. Additionally, a new addressable fire alarm system for the entire campus should report from a single location in order to allow first responders to more clearly identify the type of emergency they are facing and react appropriately. Mass notification, an increasingly vital part of school emergency preparedness, would be included in the upgrade of the fire alarm to allow various types of emergency messages to be broadcast throughout the school in order direct staff response to specific emergencies and threats.

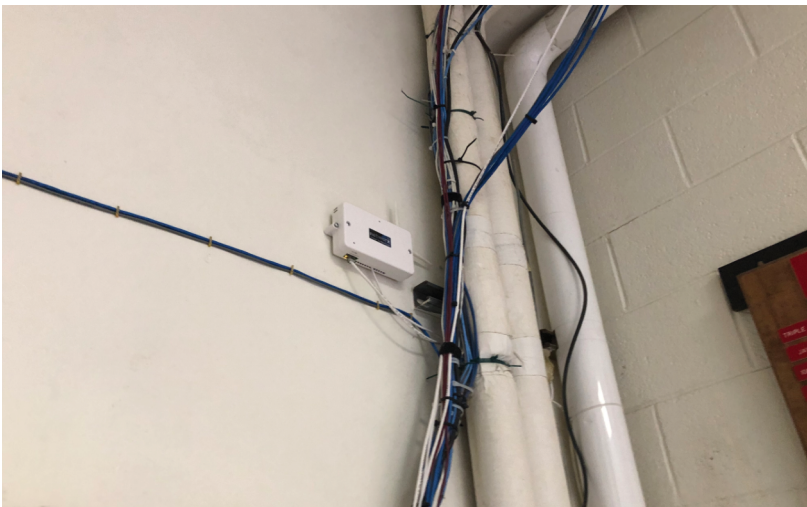
2. Cable Routing and Organization: IT cabling, fire alarm cabling, and temperature controls cabling have been routed and fastened open in hallways. While this is primarily an aesthetic issue it also makes maintenance more difficult.

Open, Mixed Cabling Systems.

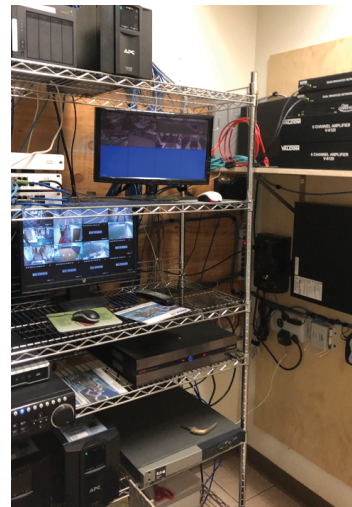
1. IT Space Upgrades: The need for a dedicated room for IT equipment is driven by three concerns:
 - a. Equipment Protection: IT equipment is extremely sensitive to heat and moisture. The location of the IT equipment in an uncooled space next to a boiler room in an open janitor's closet is a threat to the longevity of the equipment.

IT Infrastructure.

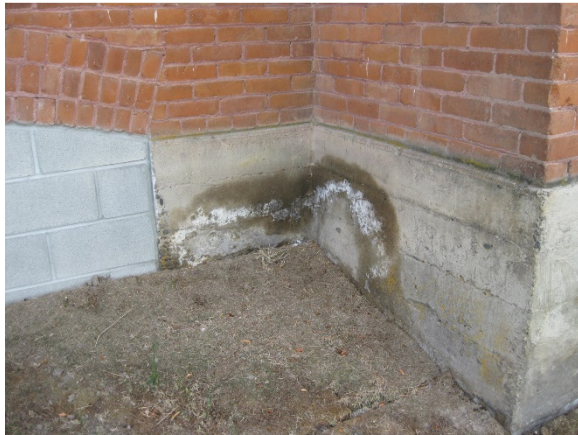
The concrete foundation walls are in good condition. The inside corner of the east wall of the porch and the east end of the north wall of the building have efflorescence (salts being driven from the interior of the concrete to the exterior by following moisture.) This isolated condition may be the result of

irrigation water hitting this portion of the building or an overflowing gutter above.

Foundation- Northeast corner of porch.

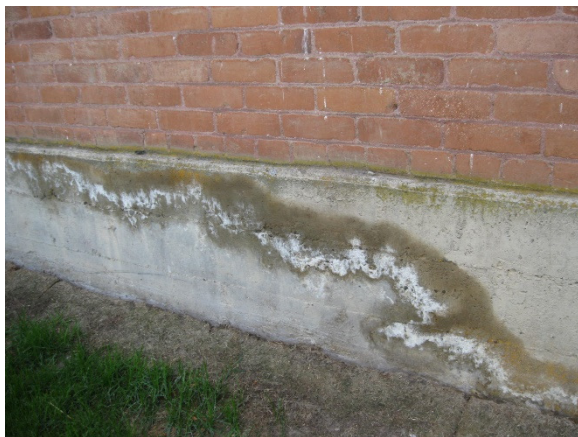
Foundation – North wall east end.

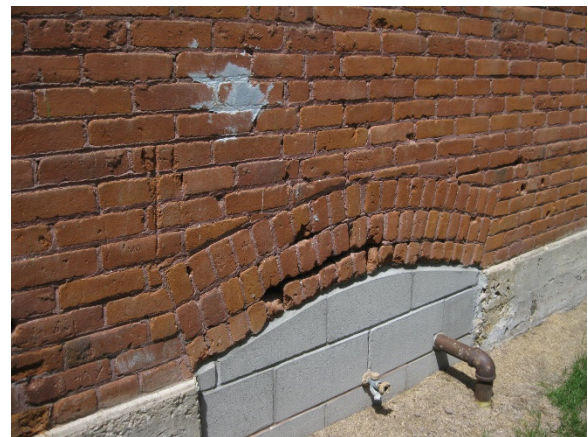
In general the existing masonry walls are performing well and exhibiting minimal wear. The mortar between the brick at the window sills has eroded over time. The northeast corner of the masonry wall has efflorescence (salts being driven from the interior of the wall to the exterior by following moisture.) There are minor cracks in the masonry between the basement and the first floor windows at the west end of the north elevation. There are minor holes in the masonry at the east elevation south basement window.

Masonry Wall – East elevation.

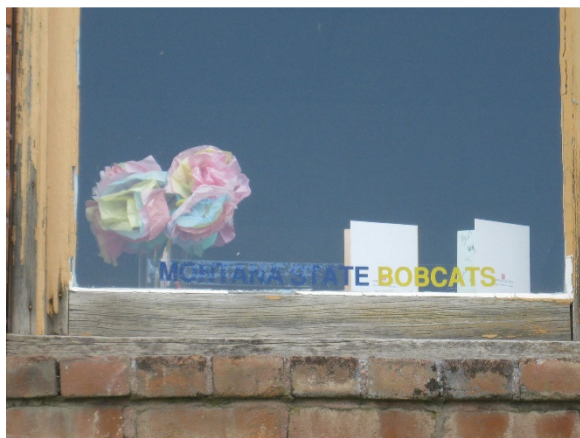
The condition of all of the windows is generally good. The exterior paint has begun to peel and is now ready to be prepared and painted. The glazing putty is loose and or cracked at most sash. There does not appear to be any weather-stripping. The sealant in the joint between the window jambs and the masonry has dried out and cracked. The casement window in the first floor Men's Toilet Room is missing hardware and has been sealed shut with sealant.

Window - Sill

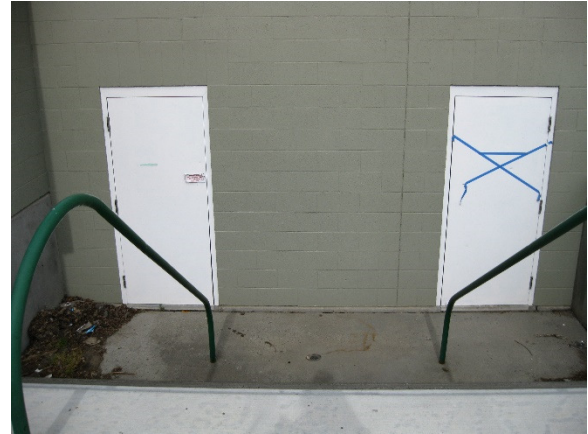
There appears to be a depressed area north of the 1914 building entry that may retain storm water. The east gymnasium egress doors have debris at the landing which could block the floor drain.

Egress Doors - East Gymnasium

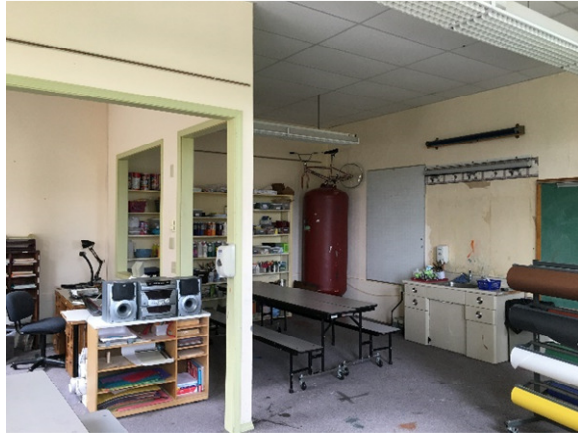
The flooring in the classrooms and hallway is nearing the end of its useful life and will need to be replaced within 5-7 years. The present art room flooring is heavily stained. The carpet in the stairway from the ground floor

of the adjacent school building to the second floor is worn and should be replaced within 3-5 years. The base is presently in serviceable condition.

Floors – Art Room

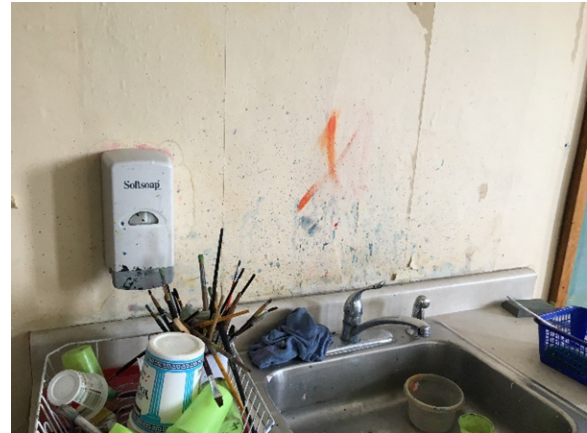
The west wall of the art room above the sink is severely stained.

Interior Walls - Art Room west wall.

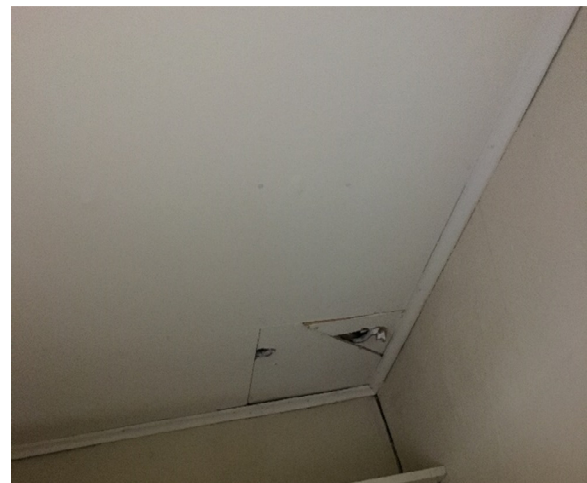
The 2x4 lay-in ceilings are all in good condition. The plaster or gypsum board ceilings in the small storage rooms have holes in them.

Ceilings – Storage room patch.

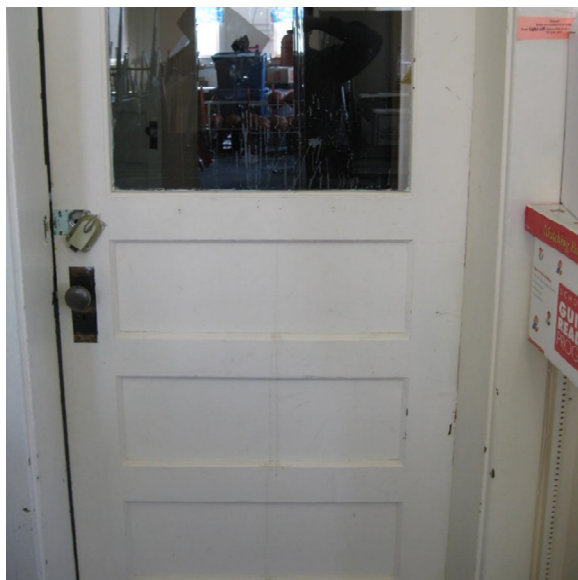
The glass lites in the second floor doors are not safety glass. The door hardware on the second floor classroom doors is not functioning.

Remove the glass lites in the second floor classroom doors and replace with safety glass. Remove and replace the second floor classroom door hardware.

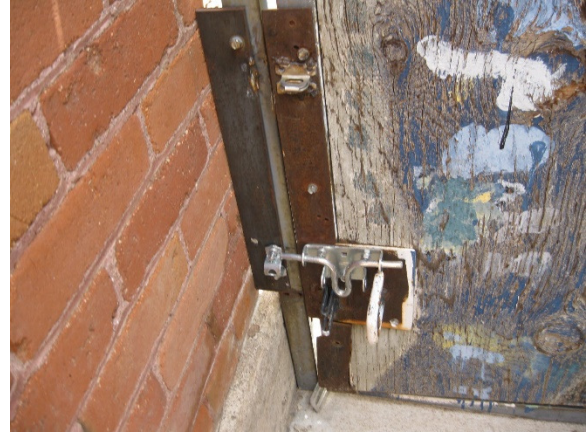
The fire escape appears to be in serviceable condition and compliant with Chapter 34 of the IBC. The gate in the fence at the bottom of the stair does not meet code-required head clearance of 6'-8". The latching door hardware does not meet IBC Section 1008.1.1 requiring doors to have panic hardware for occupant loads over 50.

Fire Escape – Gate Bolt

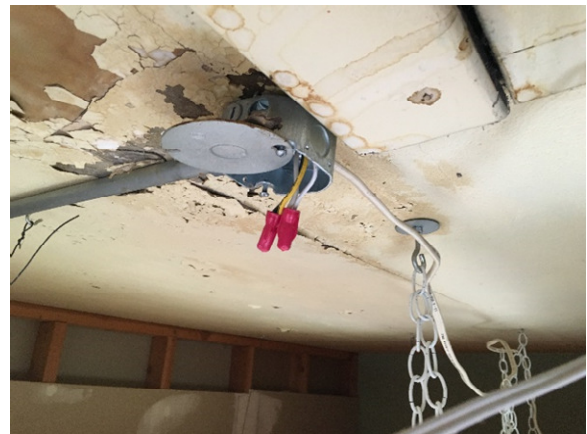
Miscellaneous – Exposed Electrical Wiring

Conceal all electrical splices with in approved junction boxes.

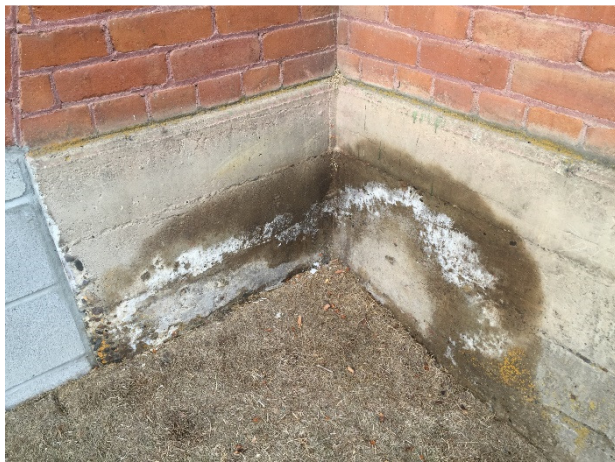
The concrete basement walls were in generally good condition. There were no signs of cracking to indicate ongoing settlement. While there were some signs of water infiltration, the concrete remained intact at these locations.

Figure 4: Area of water infiltration in the basement below.

While the basement floor showed signs of deterioration and cracking, this is not a life-safety structural issue. If the uneven floor surface becomes a serviceability issue, there are options for floor leveling using a topping slab that could be used for remediation. Steps should be taken at the exterior of the building to remediate the water infiltration issue; this would be coordinated with a civil and/or geotechnical engineer.

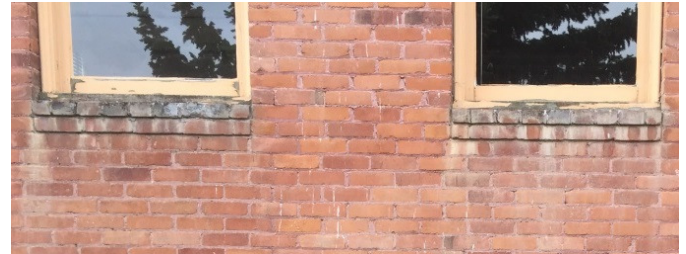
In particular, the window sills have degraded due to water as seen in the figure below. The brick at these sills may need to be totally removed and replaced.

Figure 5: Brick at window sills has deteriorated.

- Brick repairs including removing and replacing existing deteriorated brick or repointing existing brick (4).
- Provide a new elevator core (or stair core) with sheathed shear walls (10).
- Provide new sheathed 2x4 furring walls at the interior of the existing brick walls to serve as shear walls (9).

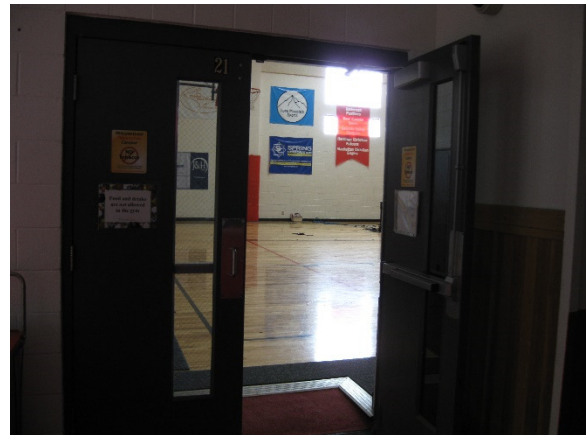
The allowable occupancy capacity of the Gymnasium is limited by the existing egress width. The allowable occupancy of the space should be permanently posted at each exit from the Gymnasium. This is also noted on the exiting diagram A101 at the end of this section.

Gymnasium Entry Doors

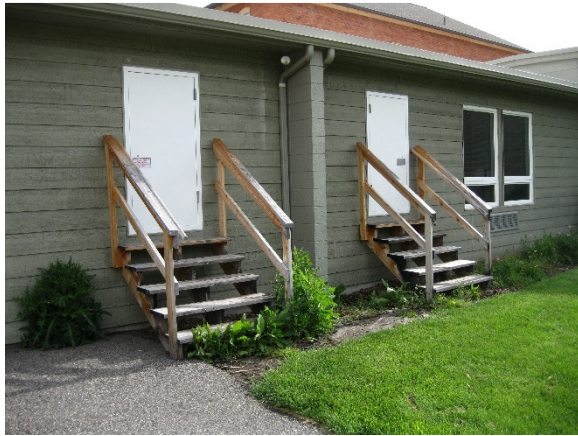
The four classrooms within the 1966 addition an exit door/opening to the exterior raised above the floor level. The size and location of these appear to be replacing a former window opening in the wall. The openings are 30" wide x 63" tall and are 34.5" above the finish floor. Each door/opening has a panic hardware and stair with a handrail on the exterior side only. Currently there is no accessible route from the interior side of the room to get to the opening height. Due to the height of the sill above the finish floor the IBC requires a guard rail and handrail at these locations. The current exterior handrail does not provide guard rail protection. The required guard rail require a balustrade with limited opening. The existing stair only provides a handrail on one side of the stair.

Egress stairs require handrails on each side of a stair.

Egress doors at 1966 building

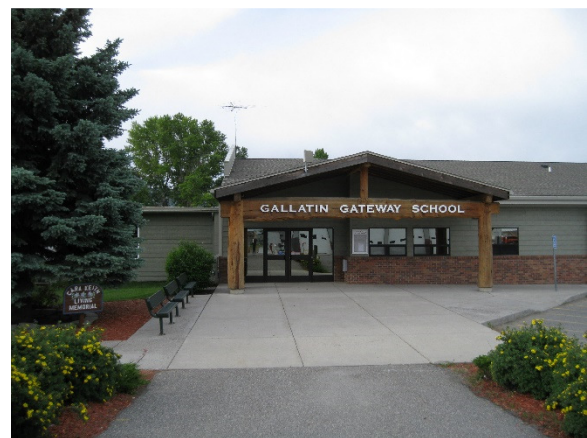
The main entry to Gallatin Gateway School from the exterior is easy to identify and provides overhead weather protection outside to create a safe exterior waiting area. The administration is near the point of entry and has partial visibility to the exterior. The more visibility an administrator has to the exterior and interior creates greater opportunity for natural surveillance. The entry sequence from the main entry through the vestibule to the administration desk could be improved for safety by directing visitor through a single port of entry strait to the administration focal point or desk. See Entry Sequence Options at the end of this section.

Main Building Entry

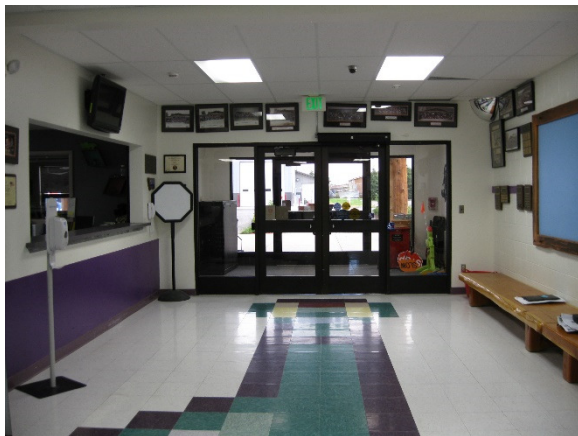
The main lobby of the school is used during school and after hour use. It is important to make this area easily secured and closed off from the remainder of the school at a moment's notice to prevent unauthorized access. The design of the existing lobby would require one additional corridor to be secured (doors between lobby and 2003 addition) to follow this guideline. See Lobby sketch option in the Appendix.

Building Lobby

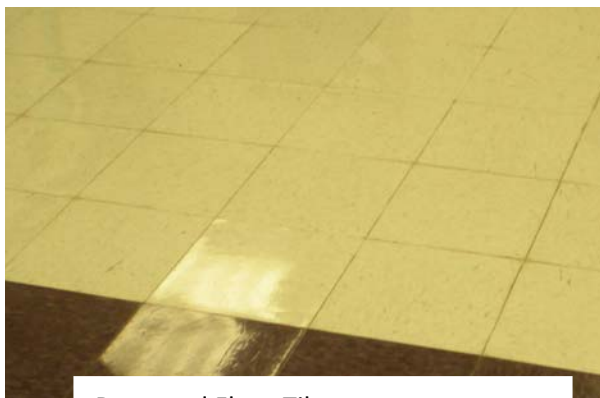
The existing crawl space ventilation system has failed which is causing mold growth and damage to the floor tiles directly above. The exhaust fans that serve the crawl space are not tied to the building's digital control system and do not have alarms in place to notify maintenance staff when they have failed.

Damaged Floor Tiles
